Influence of Elevated Temperature on the Mechanical and Microstructural Properties of Glass Fiber-Reinforced Polymers

Abstract: Glass fiber-reinforced polymers (GFRPs) have attracted significant attention as structural materials because of their high fatigue resistance, corrosion resistance, strength, and stiffness. This study examined the effect of elevated temperatures (150, 250, 350, and 450°C) on the microstructural and mechanical properties of GFRP plates. The number of bubbles increased as the firing temperature increased, and the bubbles burst at 250°C or higher, forming pores on the surface. A tensile test was conducted, and the maximum stress of the GFRP plates fired at 150, 250, and 350°C was reduced from 54.2 to 52.2, 40.3, and 24.0 MPa, respectively, compared to that of the unfired GFRP plate. Meanwhile, the elastic moduli of the GFRP plates fired at 150, 250, and 350°C reduced from 19.1 to 18.3, 16.1, and 12.1 GPa, respectively, compared to that of the unfired GFRP plate. This reduction in the mechanical properties of the GFRP plates at elevated temperatures was attributed to the degradation of the mechanical properties of the resin matrix due to glass transition and

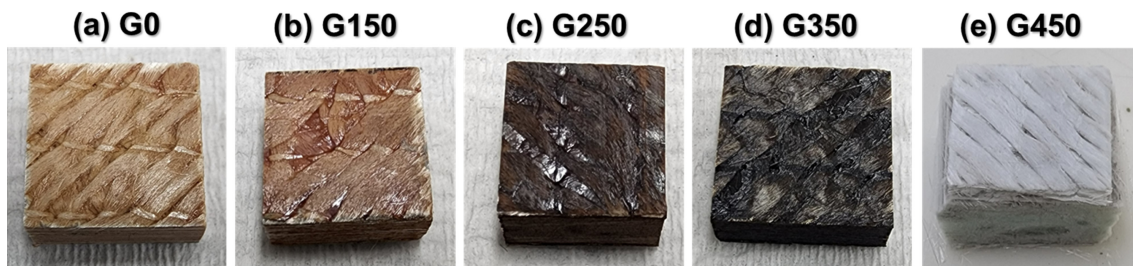
**Fig. 1.** Photographs of the GFRP plates: samples (a) G0, (b) G150, (c) G250, (d) G350, and (e) G450.

Figures 1(a)–(e) show photographs of G0, G150, G250, G350, and G450, respectively. After the heat treatment, the samples exhibited a significant change, which was visible to the unaided eye. The colors of G0, G150, G250, and G350 became darker as the firing temperature increased, which was partially attributed to the oxidation of the phenolic resin matrix [22]. Finally, for G450, the resin matrix completely evaporated, and only the glass fibers remained.

fiber corresponds to the amorphous halo of the phenolic resin matrix [25]. As shown in Figure 2(b), various components of GFRP were identified: color index (C.I.) Solvent Yellow 56, also called 1-phenylazo-4-N,N-diethylaniline ($\text{C}_{16}\text{H}_{19}\text{N}_3$, JCPDS #00-047-2143), nylon ($((\text{C}_{15}\text{H}_{27}\text{N}_3\text{O}_3)_n)/(\text{CO}(\text{CH}_2)_6\text{NHCO}(\text{CH}_2)_4\text{NHCO}(\text{CH}_2)_2\text{NH})_n$, JCPDS #00-047-2017), and alumina (Al_2O_3 , JCPDS #00-047-1771). C.I. Solvent Yellow 56 is a synthetic organic dye belonging to the azo dye family, which is widely used as a coloring agent in various applications. The peaks for C.I. Solvent Yellow 56 disappeared at temperatures above 250°C , which was in accordance with the fact that the G250 sample lost most of its initial color, as shown in Figure 1(c).

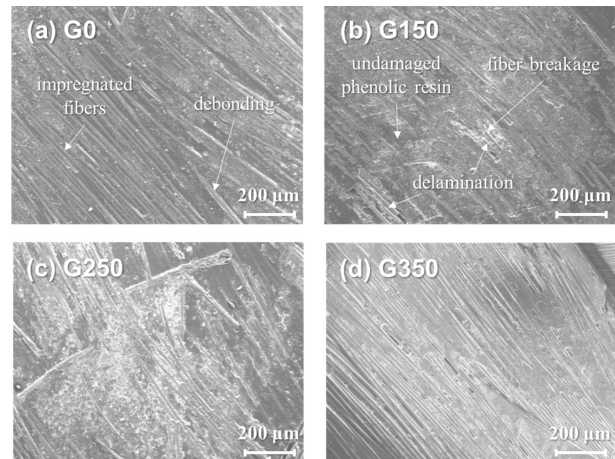
Fig. 3. Low-magnification ($\times 100$) FE-SEM images of samples: (a) G0, (b) G150, (c) G250, and (d) G350.

Figures 3(a)–(d) and 4(a)–(d) show low-magnification ($\times 100$) and high-magnification ($\times 1000$) FE-SEM images of the G0, G150, G250, and G350 samples, respectively. Some surface defects such as debonding, fiber breakage,

delamination, and bubbles were observed in the G0 and G150 samples. These surface defects are known to form after the machining of FRP composites. Morkavuk et al. [31] reported that the machining process can produce defects such as debonding, micromatrix cracking, delamination, fiber pullout, and fiber breakage due to the applied stress and generated heat.

No significant difference was observed between the G0 and G150 samples in the low-magnification FE-SEM images (Figure 3); however, the high-magnification images showed that the surface of the G150 sample was covered with more bubbles than the G0 sample. For the G150 sample, these bubbles were generated by the air in the intrinsic voids near the surface,

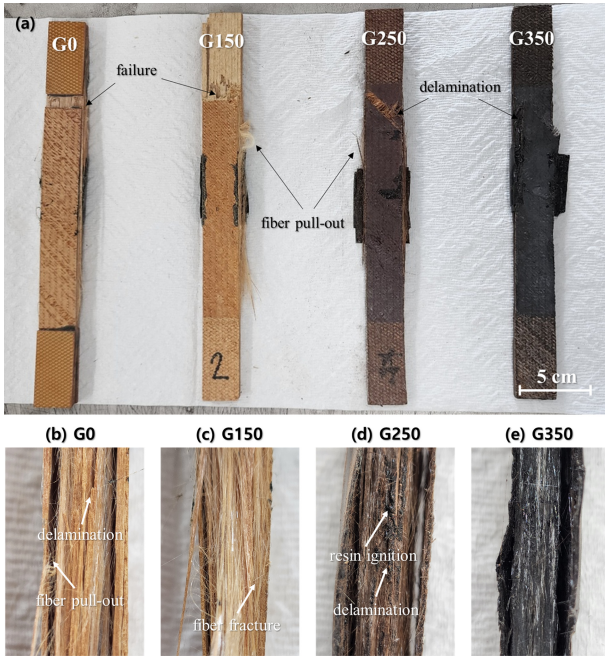
Fig. 5. (a) Failure modes of specimens: G0, G150, G250, and G350. Cross-sectional failure modes of specimens: (b) G0, (c) G150, (d) G250, and (e) G350.

which were expanded by firing and pushed out the phenolic resin matrix. At 250°C, many of these bubbles burst from overstress and generated pores on the surface (Figure 5(c)).

Figure 5 shows the failure modes of the specimens after exposure to elevated temperatures. Specimens G0 and G150 exhibited similar failure modes. Fiber pull-out, fracture, and delamination were observed in these specimens. For the G250 and G350 specimens, resin ignition and severe delamination occurred, and numerous fiber fractures were observed in the cross-sectional photographs of the specimens, which can be attributed to the glass transition and decomposition of the resin matrix at the temperatures above T_g and T_d , respectively. Bazli et al. [33] demonstrated that as the temperature increases, fiber separation and delamination

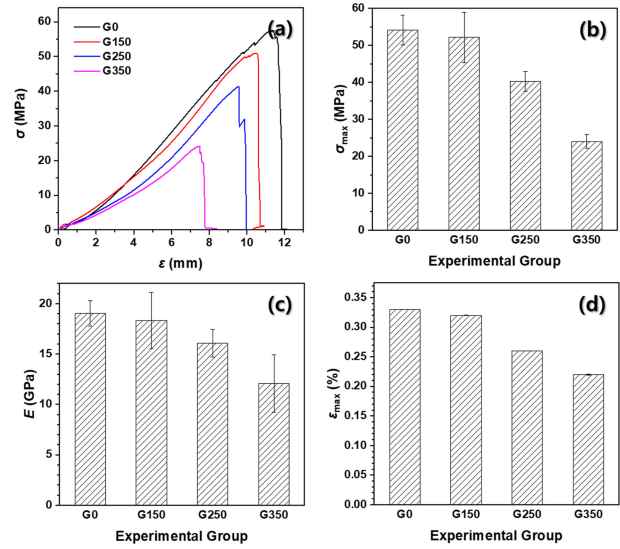
Fig. 6. (a) Stress–strain curves of specimens: G0, G150, G250, and G350. (b) σ_{max} , (c) E , and (d) ϵ_{max} of specimens: G0, G150, G250, and G350.

Figure 6(a) shows the stress–strain curves for specimens G0, G150, G250, and G350. The maximum tensile stress (σ_{max}), maximum strain (ϵ_{max}), and elastic modulus (E) were obtained from the stress–strain curve of each specimen and are listed in Table 2. Figures 6(b) and 6(c) present the σ_{max} and E for the specimens, respectively. The σ_{max} values were 54.18, 52.16, 40.26, and 24.02 MPa for G0, G150, G250, and G350, respectively. The σ_{max} values of G150, G250, and G350 decreased by 3.73, 25.69, and 55.67% compared to that of G0. In addition, the E values of G150, G250, and G350 also decreased by 3.78, 15.70, and 36.59% compared to that of G0.

The σ_{max} and E decreased gradually with increasing temperature. The mechanical degradation of the FRP composites at elevated temperatures was in agreement with previous studies. For instance, Sayed-Ahmed et al. [34] found that the exposure of FRP tendons to temperatures of 200, 300, and 400°C reduced their strength by approximately 10, 37, and 74%, respectively. Further, Wang et al. [16] demonstrated that GFRP bars under elevated temperatures of 120 and 500°C decreased their tensile strength by 22 and 67%, respectively. Cao et al. [35] also reported that

the tensile strength of FRP sheets were reduced when they were exposed to a temperature of 200°C. The reduction in σ_{\max} and E was attributed to various factors such as the degradation of the mechanical properties of the resin matrices due to glass transition and decomposition, debonding, and an increase in surface defects. Jarrah et al. [36] asserted that the glass transition and thermal decomposition of the resin matrix greatly reduced the tensile strength of GFRP and CFRP sheets. They also reported that the tensile strengths of FRP sheets decreased because of the formation of cracks due to oxidation, leading to debonding and a further reduction in the tensile strength of the specimens.

Figure 6(d) shows the ϵ_{\max} values of each specimen. The ϵ_{\max} values were 0.33, 0.32, 0.26, and 0.22% for G0, G150, G250, and G350, respectively. The ϵ_{\max} values decreased gradually with increasing firing temperature, which indicates that the brittleness increased with increasing temperature. Brittle fractures of FRP composites can cause cracks and lead to mechanical failure during operational service, even at low mechanical loads [37]. Therefore, it can be concluded that the high brittleness of the heat-treated samples caused their degraded mechanical strength. Furthermore, as shown in Figure 4(d), numerous large pores, microcracks, and severe delamination were observed on the surface of the G350 sample, which is in accordance with its high brittleness and a significant decrease in its mechanical properties.
